# Manhole Inspection Summary

Manhole # S37E\_\_056MH

Insp Date: **10/20/08 2:44 PM**

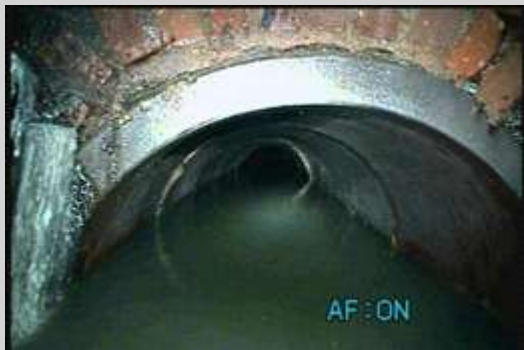
12 O'Clock Outflow

27 in. Circular Gravity Sewer  
Pipe Out @ 12 O'Clock

Pipe Height: 0 (in.) Direct

Pipe Material: **Clay** ☐ Pipe Lined

Invert Depth: **16.25** (ft.) Flow Characteristics: **Slow**

Deposits: ☒ None ☐ Mud ☐ Sludge ☐ Debris ☐ Grease

Infiltration: **None** Pipe Seal Cond: **Unknown**

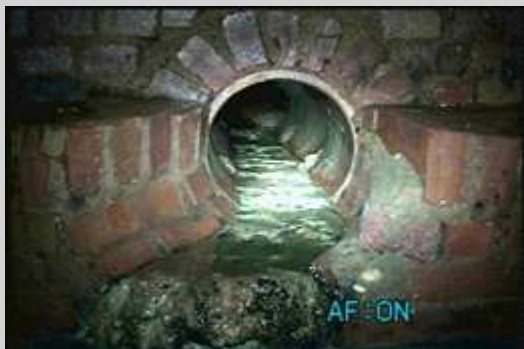
3 O'Clock Inflow

10 in. Circular Gravity Sewer  
Pipe In @ 3 O'Clock

Pipe Material: **Clay** ☐ Pipe Lined

Invert Depth: **15.00** (ft.) Flow Characteristics: **Slow**

Deposits: ☒ None ☐ Mud ☐ Sludge ☐ Debris ☐ Grease

Infiltration: **None** Pipe Seal Cond: **Unknown**

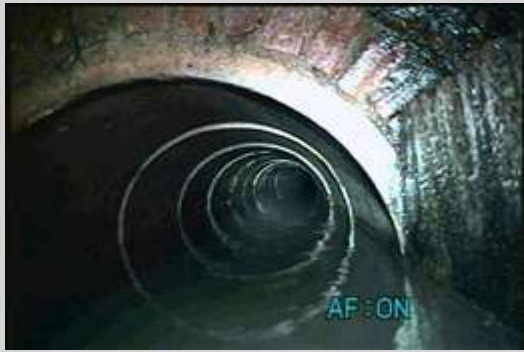
6 O'Clock Inflow

27 in. Circular Gravity Sewer

Pipe In @ 6 O'Clock

Pipe Material: **Clay** ☐ Pipe Lined

Invert Depth: **16.10** (ft.) Flow Characteristics: **Slow**

Deposits: ☒ None ☐ Mud ☐ Sludge ☐ Debris ☐ Grease

Infiltration: **None** Pipe Seal Cond: **Unknown**

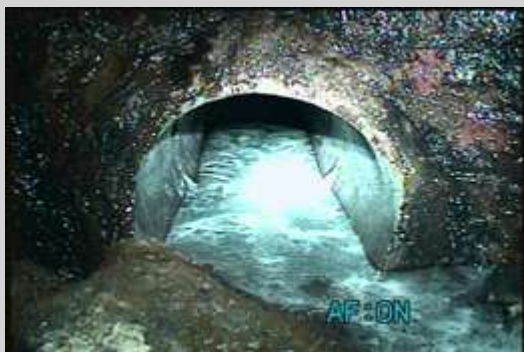
10 O'Clock Inflow

10 in. Circular Gravity Sewer

Pipe In @ 10 O'Clock

Pipe Material: **Clay** ☐ Pipe Lined

Infiltration: **None** Pipe Seal Cond: **Unknown**
